STATE OF CALIFORNIA  
DEPARTMENT OF PUBLIC WORKS  
DIVISION OF HIGHWAYS

CUT SLOPE DESIGN AND LANDSLIDES  
SOME CASE HISTORIES

T. W. Smith and H. R. Cedergren

Prepared for  
A.S.T.M. Meeting  
Los Angeles

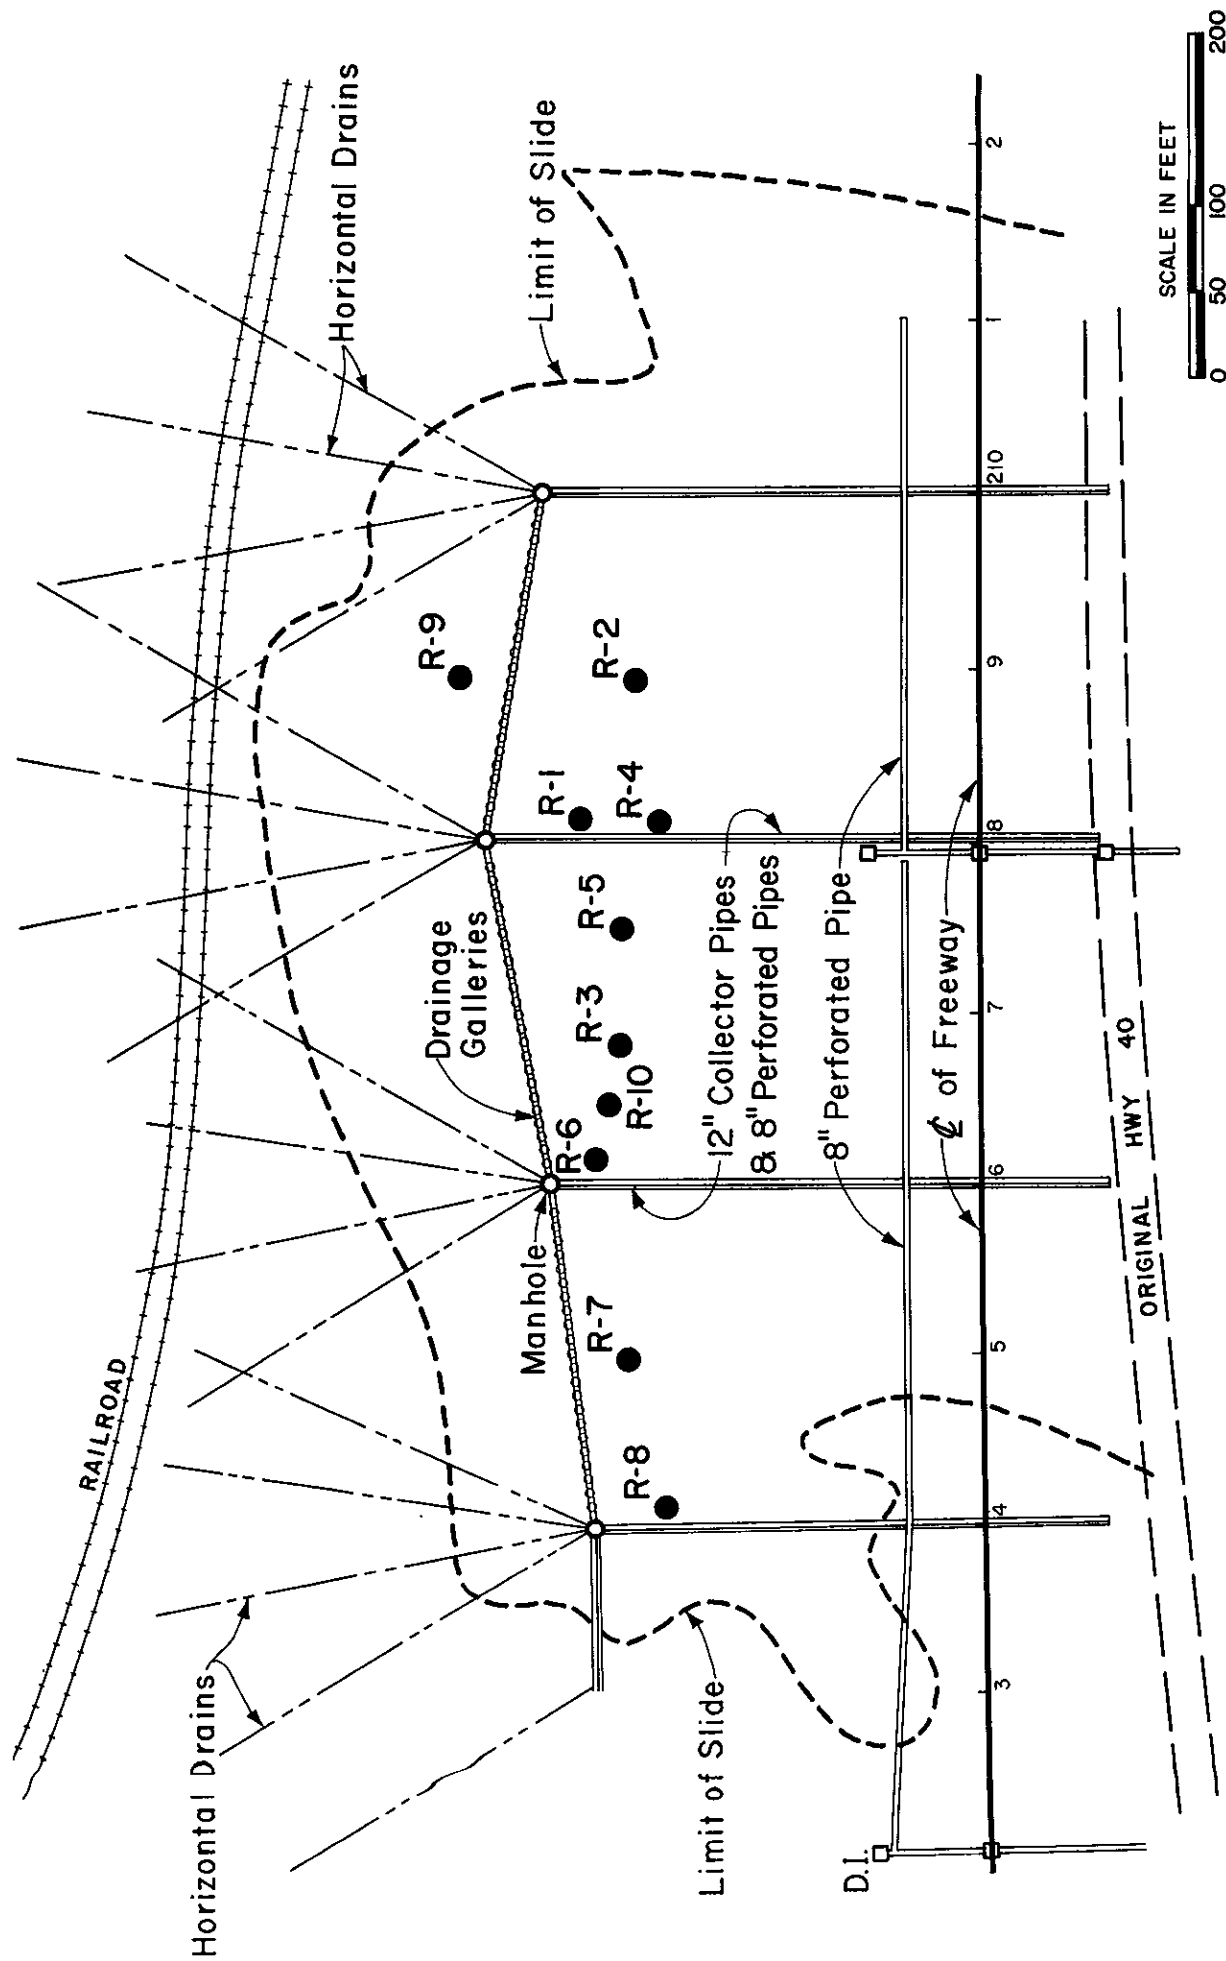
FIG. 18 PLAN SHOWING STABILIZATION DETAILS AND BORING LOCATIONS AT TOWLE SLIDE

After completion of these stabilization trenches and a winter shutdown on construction operations, borings were made to determine whether the trenches had been effective in removing the ground water from the entire area. It should be noted that the construction of the trenches removed less than one-third of the slide mass in the area of the trenches. Any increase in stability of the mass remaining in place was dependent upon decreasing moisture contents and hydrostatic pressures by drainage. It was found that the ground water was standing quite high in the area between the trenches, and it was decided that further drainage facilities would be necessary.

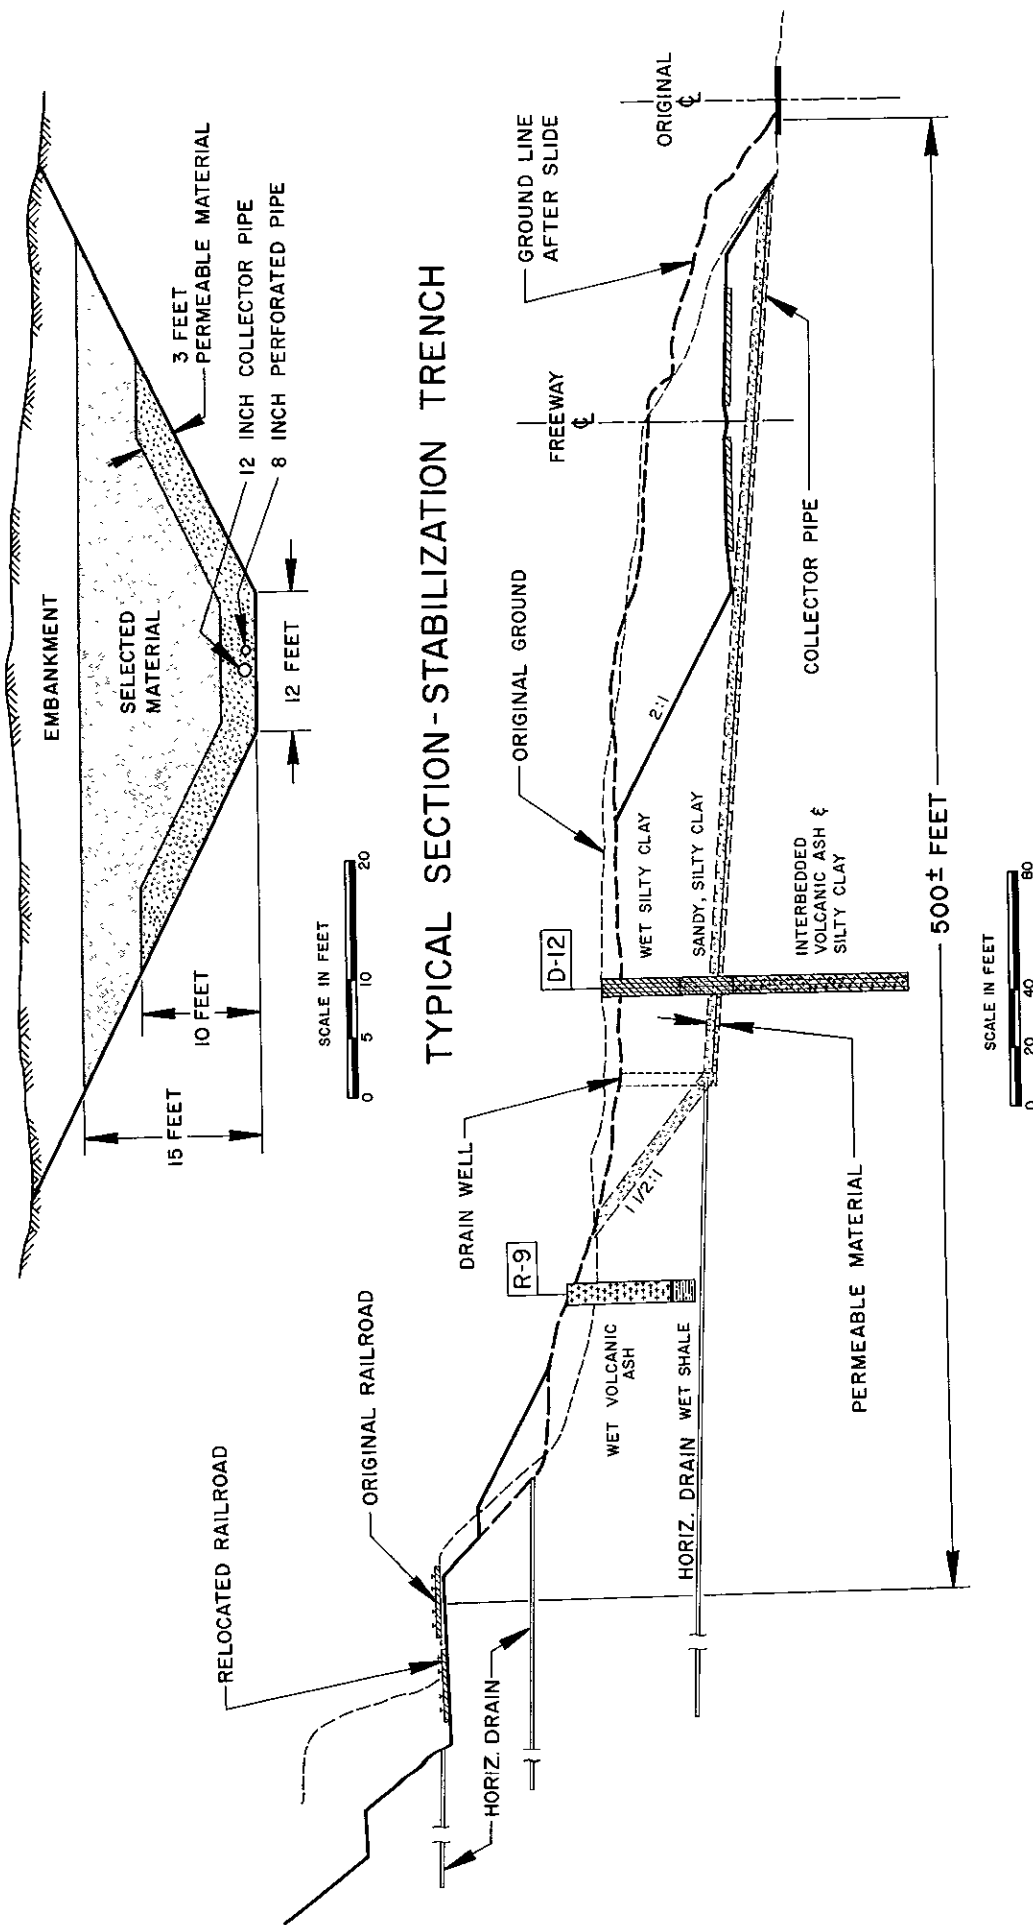
FIG. 19 PROFILE AND TYPICAL SECTION OF STABILIZATION TRENCH AT TOWLE SLIDE

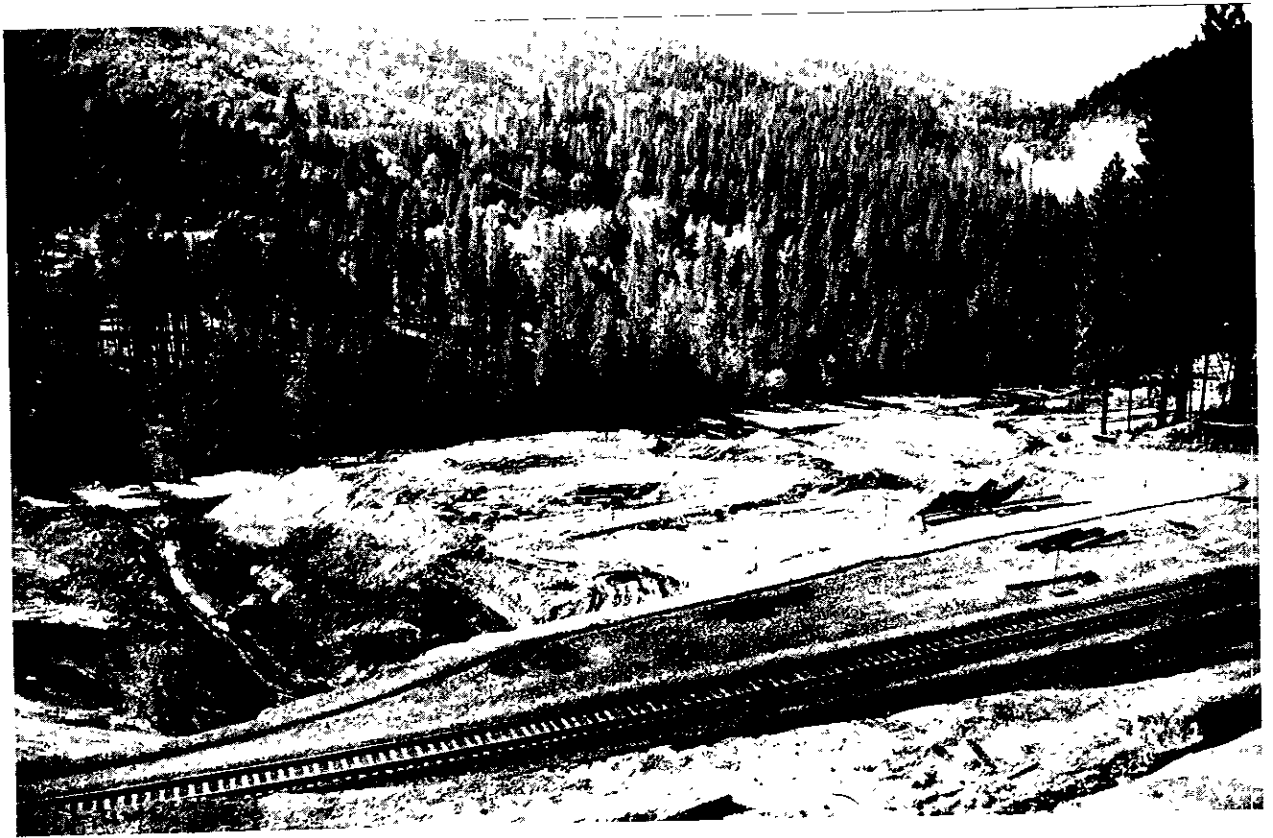
Fig. 20 - View Showing Stabilization Trench at Towle

There have been no serious signs of distress or movement in this area after completion of the freeway. There has been some sliding beyond one end of this stabilized area, thus confirming the need for stabilization and indicating that the stabilization should have been extended. However, it should be kept in mind that the two winters since the completion of this installation have not been severe and hence ground water conditions may not have provided a real test of the effectiveness of this installation.
